Fixing Column

Problems from

rebuild two-storey columns for another century.

the Ground Up

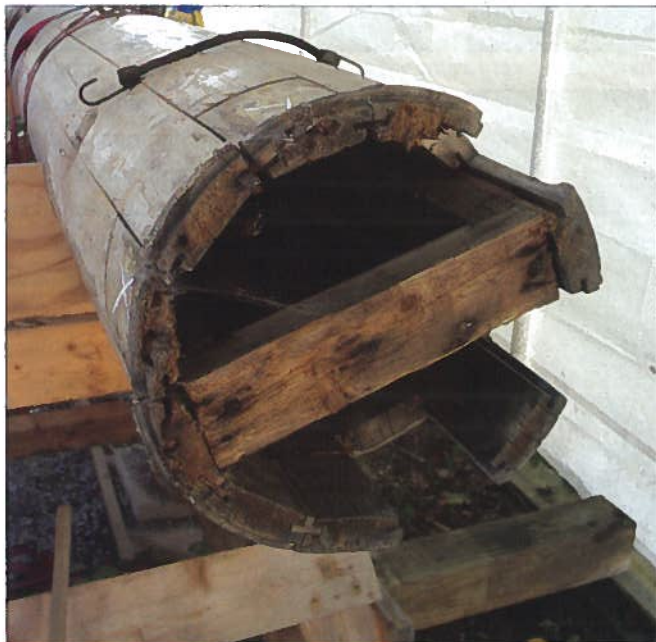
Once the columns were removed from the building, the extent of the damage was obvious. The bottoms of many staves were not only unsalvageable, but also missing wood in some areas.

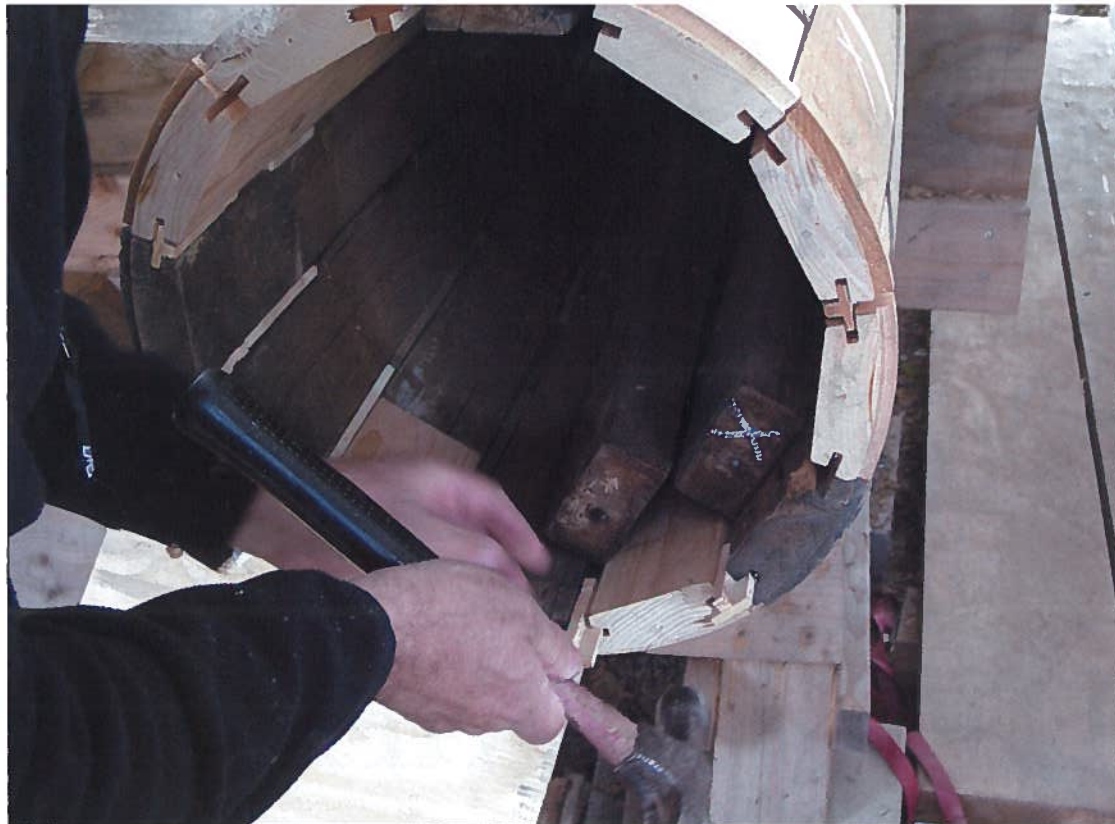
Each of the column staves is connected to its neighbors by T-shaped splines, which also had to be replaced once the repaired stave sections were in place. In the past, each column manufacturer had its own locking system.

With the replacement stave parts in hand, we cut each piece to the correct lengths. To insert a new piece, we tapped it into place working up from the bottom of the column. Then we took newly made splines and tapped them into the slots using a mallet. Because the column staves have to be free to expand and contract, no epoxies or other adhesives were part of the installation process. Though the new staves exactly replicated the parts of the shaft they replaced, there were still anomalies, so we used sanders, an antique compass plane (which planes curved surfaces), and epoxy fillers to blend the old and new wood.

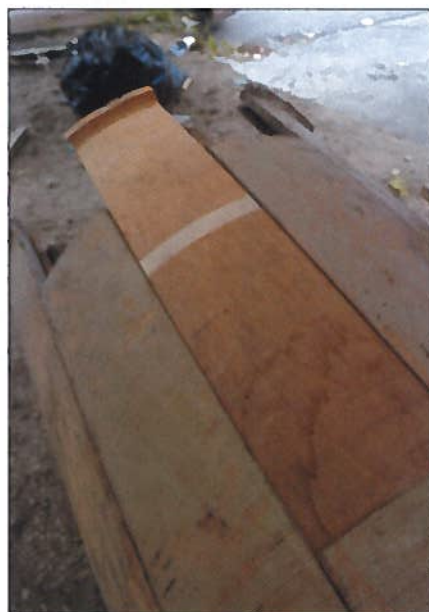
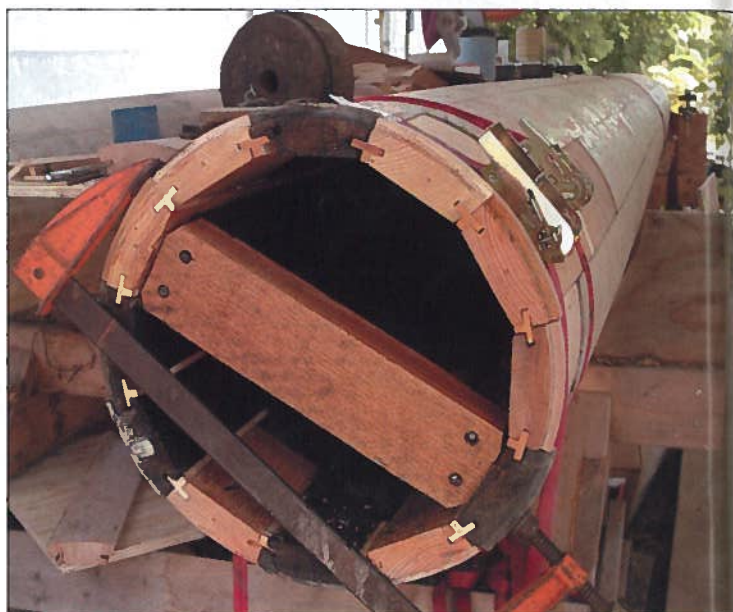
The new stave ends were fabricated to replicate as closely as possible the dimensions of the originals so that they slid into place neatly between existing staves, retaining the structural integrity of the column.

Removing the defective wood meant cutting back staves on a 12", 24", and 12" scheme around the shaft so that old and new material would knit together.

The first step was to remove the decayed wood. Because we needed to leave support material on either side of the new parts, not just remove decay up to sound wood, we decided on a scheme that alternated staff cut-backs between 24" and 12" from the end of the shaft. To sever each staff, I first laid a flexible straightedge across the column and scribed a line. Next, I bored a $\frac{1}{8}$ " hole to start the cut and then completed it by carefully sawing along the scribed line with a saber saw. Once the staff end was severed, it was a relatively simple matter to pull the defective piece straight out of the column, like removing a piece of tongue-and-groove flooring. I continued around the column in this manner, cutting back every other staff 24" and the others at 12".

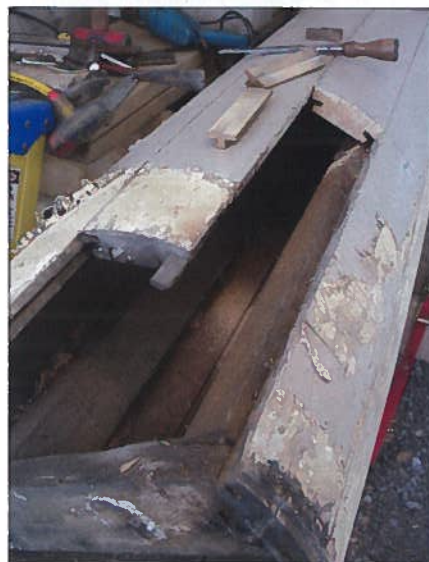
Belt and bar clamps were essential for maintaining the original dimensions and accuracy of the column bottoms as the stave ends were replaced.

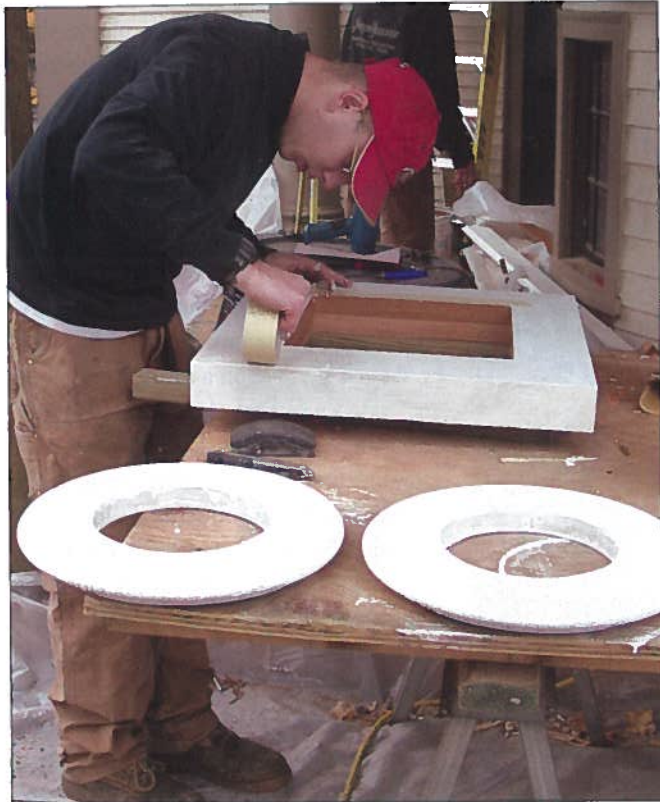
Decay below the column shafts was extensive. The plinths and bases had to be completely rebuilt out of mahogany.

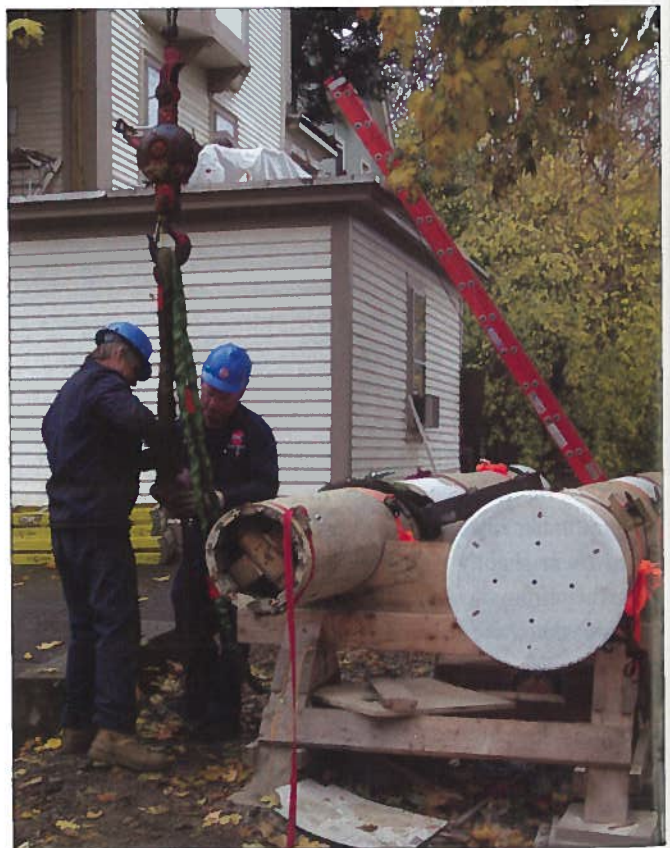
The columns, waiting for reinstallation, show a rebuilt bottom with vent holes, next to a top, still in good condition.

was originally built, we took the same belt-and-suspenders approach when we reinstalled them by adding shims under the bases to increase the vent opening.

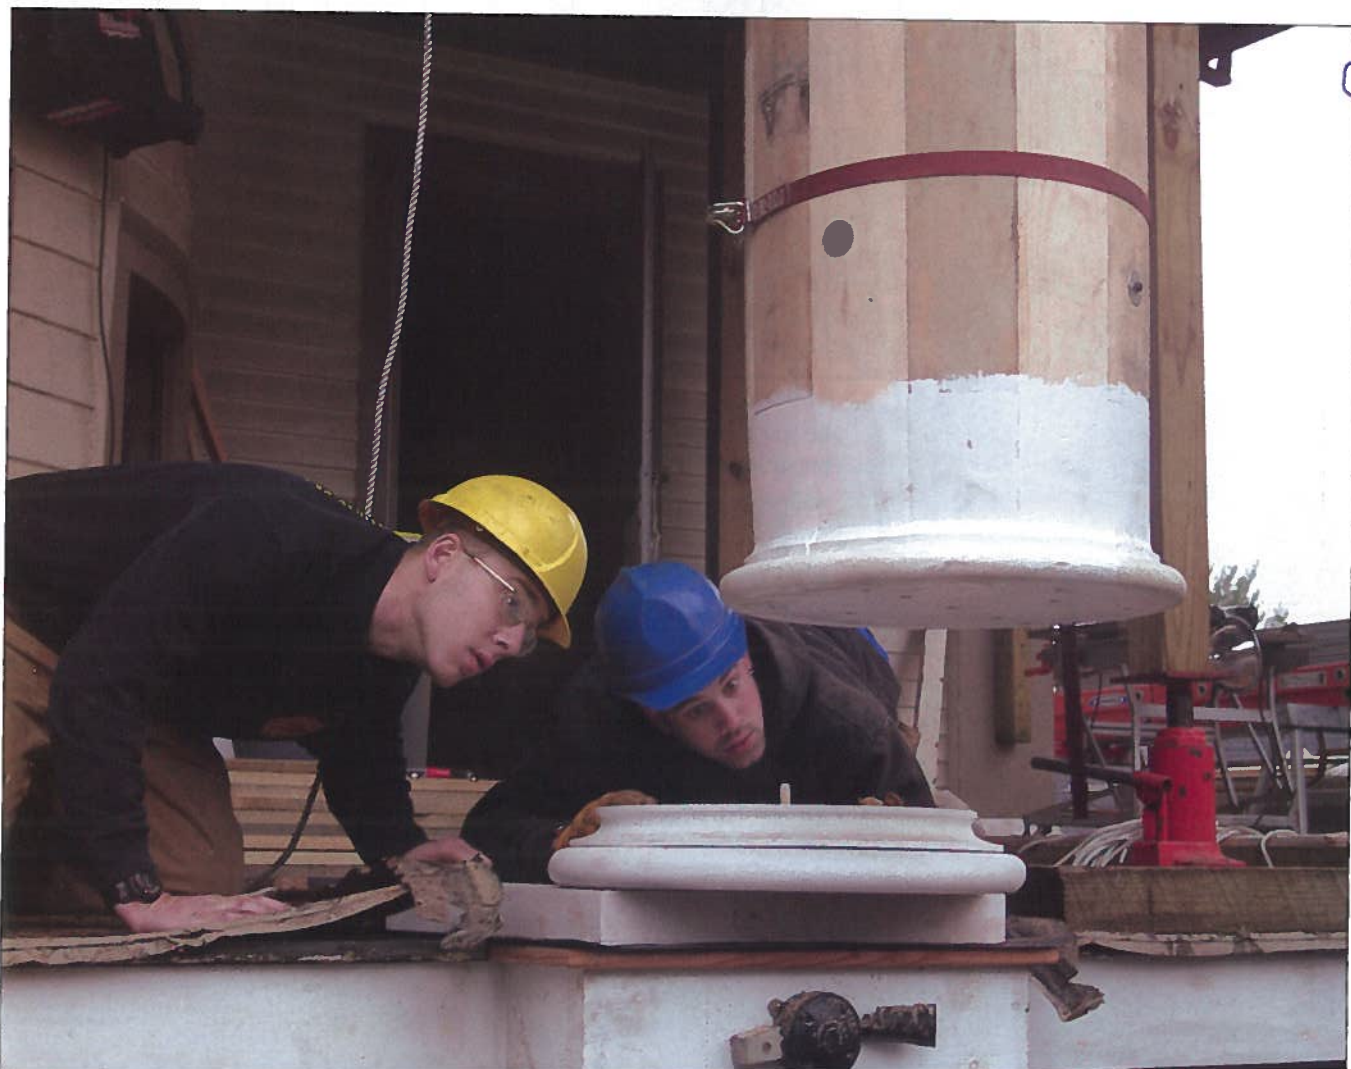
Seeing a massive, like-new column deftly lifted into place atop fabricated base parts explains why other contractors passed on the job. The project required not only problem solving and a measure of engineering, but also teamwork among three companies.
